**SUBJECT: Accident Investigation Board Report: F-15E, T/N 90-0231, 366 EFS,  
455 AEW, near Ghazni, Afghanistan, 18 July 2009**

## **EXECUTIVE SUMMARY AIRCRAFT ACCIDENT INVESTIGATION**

**F-15E, T/N 90-0231  
BAGRAM AIRFIELD, AFGHANISTAN  
18 JULY 2009**

**SUMMARY OF FACTS AND STATEMENT OF OPINION**  
**F-15E, T/N 90-0231**  
**18 JULY 2009**

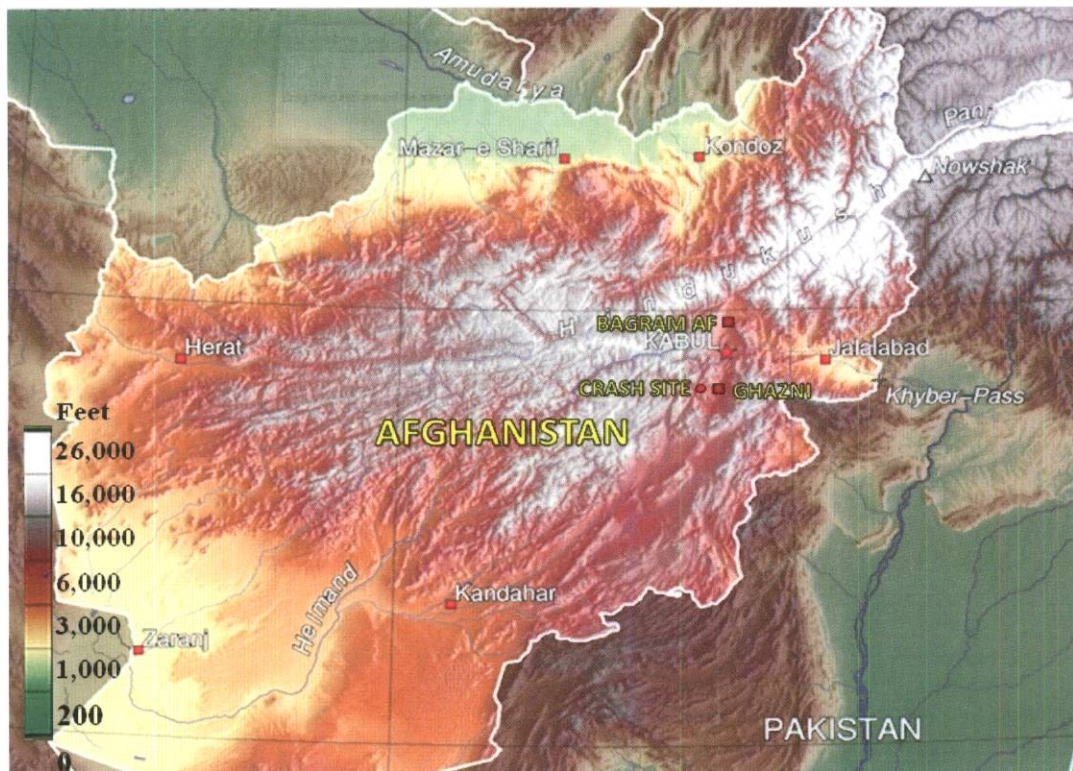
At 0209L the MF finished the CAS mission and started their return to Bagram Airfield. (Tabs L-3, N-3) The FLW set steering in the tactical situational display (TSD) to Bagram Airfield. (Tabs L-3, N-3) The TSD is a presentation of aircraft position in relation to a planned mission route superimposed over a digital map. The TSD screen displayed an elevation of approximately 4,800 ft MSL for Bagram Airfield. (Tab L-3) The FLP then asked the FLW to assess the elevation for the dry lake bed located 30 miles west of Ghazni. (Tabs L-3, N-4, V-1.5) The dry lake bed was one of the places designated by the 336 FS director of operations for practicing HAS, and aircrew routinely practiced at this location. (Tabs V-1.3, V-1.4, AA-6) The dry lake bed has an average terrain of approximately 10,000 ft and is surrounded by mountains with peaks that range from 13,000 to 16,000 ft MSL.

The FLW switched screen modes in the TSD and moved the cursors to the dry lake bed. (Tabs N-4, V-2.5, V-2.6) It took only a few seconds to move the cursors. (Tab L-3) After the FLW moved the cursors to the dry lake bed, the TSD screen displayed "DTED [Digital Terrain Elevation Data] NOT AVAILABLE." (Tab L-3) This meant that the aircraft did not have terrain elevation information in the database for that specific point. Since information must be manually uploaded into the TSD system for each point and there are thousands of points in a particular area, it is possible that some points do not have data available in the TSD. WSOs are aware of this, and the solution is to move the cursors slightly to another point where information is available. The FLW told the FLP the average terrain for the dry lake bed was 4,800 ft MSL. (Tab N-4) When the AIB asked how he arrived at his attack parameters for the dry lake bed, the FLW recalled the TSD displaying an elevation in the 4000s. (Tab V-2.4) The FLW and FLP used the TSD as their sole means of deriving the average terrain for the dry lake bed. (Tabs N-4, V-2.5, V-2.6) A warning in the F-15E Flight Manual provides, "Height Above Terrain (HAT) information on the TSD should not be used for absolute altitude reference for terrain avoidance or terrain clearance." (Tab BB-21)

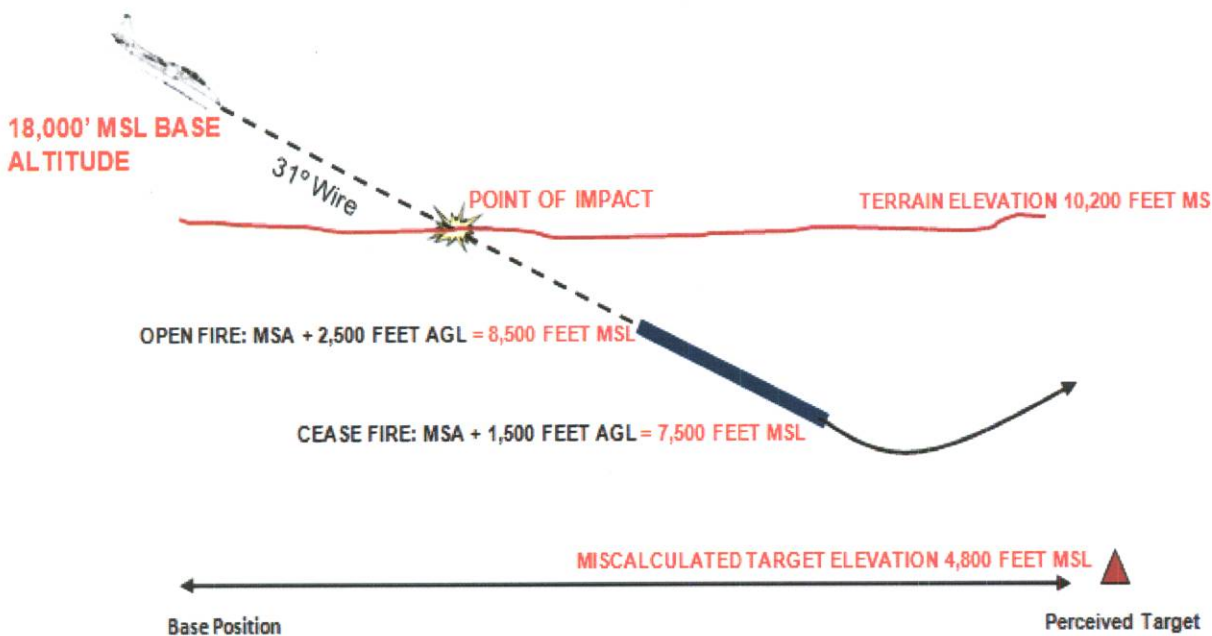
## Mishap Strafe Attempt

The MC began their descent toward the perceived target at 02:33:42L. (Tab L-3) The MC achieved a 31 degree dive angle and continued their dive until impact. (Tab L-3) Three seconds before impact, the ground collision warning system (GCWS) alerted the MC to “pull up” four times and a large arrow pointing up displayed in the MPDs and the HUD. (Tabs L-3, N-13) The GCWS warns aircrews of impending controlled flight into terrain. It is a passive warning system that does not have automatic recovery. (Tab BB-21)

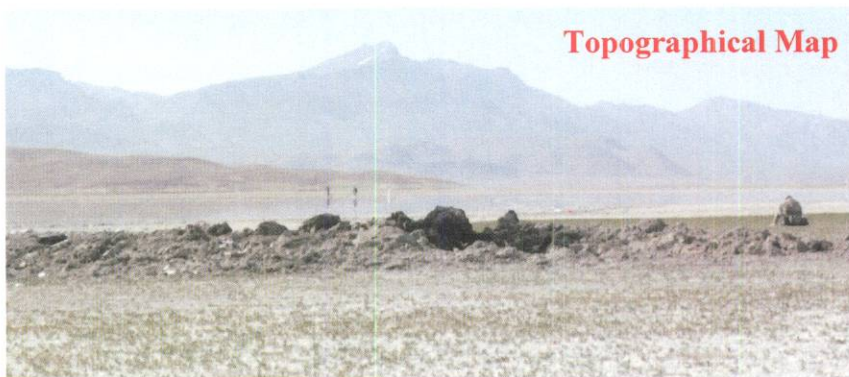
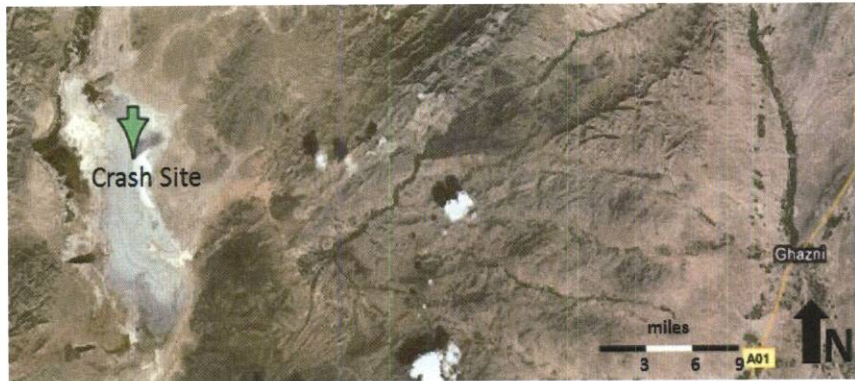
The MA impacted the ground at 02:33:52L. The MC died upon impact. (Tab B-3) The MA was destroyed. (Tab B-3, P-3) The value of the MA was \$49,721,970, and other government property was \$5,651,381.90. (Tab P-3 thru P-6) No other injuries or damage resulted from the mishap. Three seconds prior to impact, the flight parameters were approximately 470 knots

calibrated airspeed, 1,100 feet AGL, 31 degrees nose low, and descent rate of 420 feet per second. (Tabs H-3, L-3, S-3 thru S-19) Analysis of the G-suits and recovered flight videos indicate the MC made no attempt to recover. (Tab J-10, L-3)

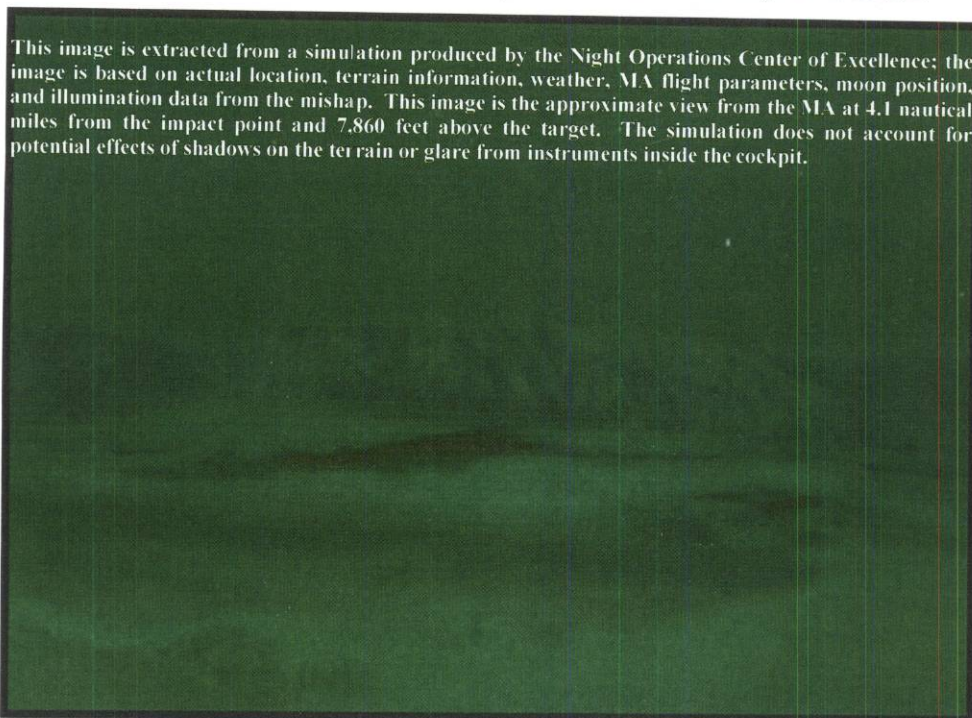
### **Simulated NVG Scene at the Dry Lakebed from 18,000 ft MSL**

The FL described a “washed out” image immediately following their aborted strafe attack. (Tab N-9) The moon was behind both aircraft on the final attack heading, but potentially in the field of view prior to turning final. Thus, the MC may have experienced some visual distortion immediately preceding or during their attack.

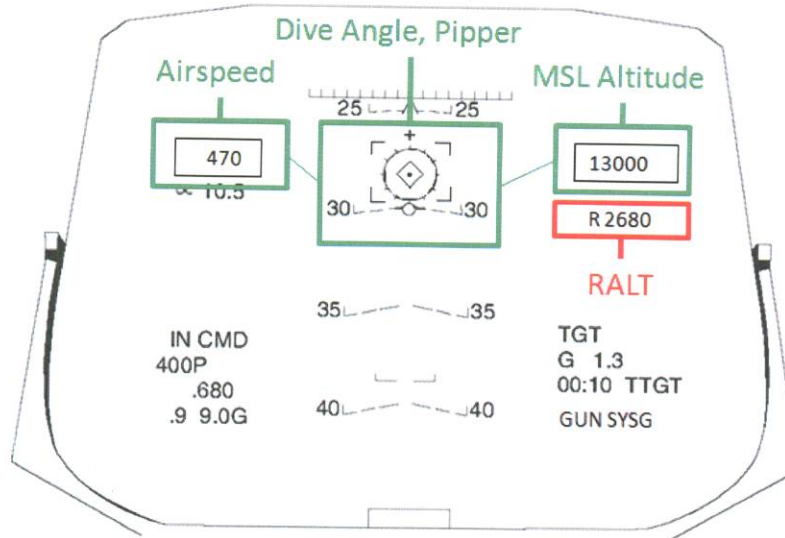
### Depiction of HUD on 30 degree HAS (Key Information Highlighted)

which can only occur in sequence at a limited speed, necessitating a prioritized cross check of pertinent information. (Tab DD-3, #2, 5) Cross check items for flying low illumination HAS attacks are airspeed, MSL altitude, dive angle, and pipper placement. Slant range and RALT are not included in the cross check. Correct attack parameters ensure terrain clearance.

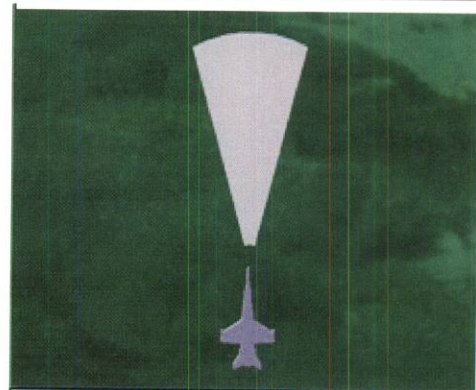
The ambient visual mode processes motion and orientation cues from the visual scene. While approaching the terrain during the day with unaided (non-NVG) vision, increased optical flow - the rapid movement of visual information across the retina - can produce a sense of "ground rush" through ambient vision. Normal field of view (FOV) is 120 degrees laterally by 80 degrees vertically, and binocular NVGs reduce FOV to 40 degrees. This reduction in FOV limits ground rush cues at night.

Depiction of 40 degree FOV with NVGs

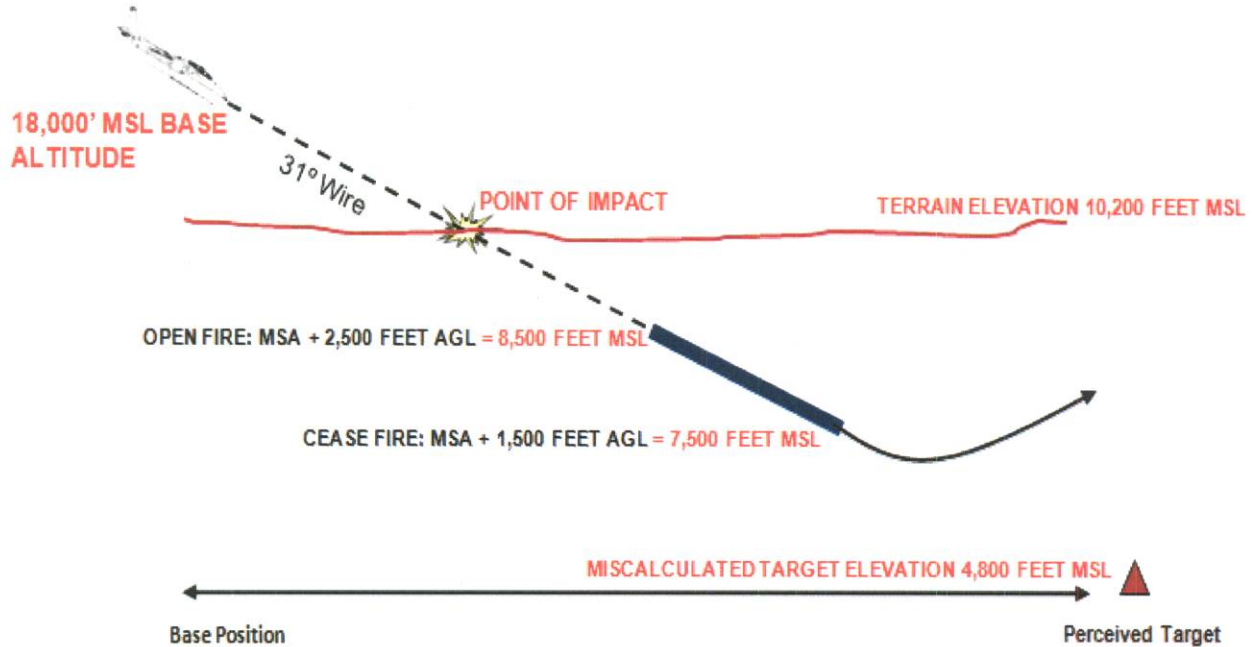
# Mishap Strafe Attempt

The mishap crew used the inaccurate target elevation data to calculate open and cease fire attack parameters of 8,500 and 7,500 feet MSL respectively. These numbers were below the actual target elevation of 10,200 feet MSL.

The flight lead initiated his attack but aborted due to a shallow dive angle. He radioed to his wingman that he aborted his attack due to the shallow angle but did not provide additional information. The mishap crew did not acknowledge this radio call and did not make any adjustments to their attack parameters.
